INTERNATIONAL CENTRE FOR AUTOMOTIVE TECHNOLOGY

TEST REPORT

3.	Description of Device under Test (DUT)	Fire Detection And Suppression System (FDSS) Name of the Manufacturer : M/s. Fogmaker International AB Trade Name/Model : Fogmaker FDSS acc. to AIS-135 Part No. (For Assembly) : 33*-AIS135 Drawing Nos. : Appendix-A , Appendix-B & Appendix - C Applicable Vehicle Category : Buses

4.	Date of Receipt of sample	NA
5.	Condition of Sample	No physical damage observed.
6.	Test Objective	To conduct test on Fire Detection and Suppression System (FDSS) as a component as mentioned at Sr. No. 3.0 above as per AIS-135: 2016.

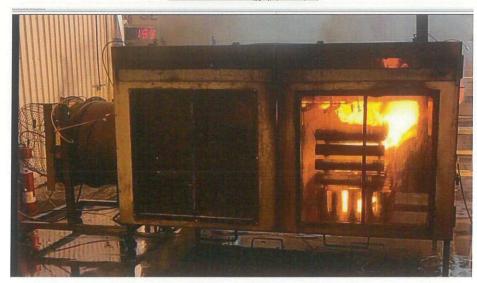
High Fire Load Scenario

Table (A) High Fire Load Scenario (as per Appendix 2):

TIME REQUIRED (mm:ss)	ACTION	OBSERVATION / ACTUAL TIME RECORDED (mm:ss)	TEST RESULT
00:00*	Start Igniting	Ignited Fire	
00:10*	Alarm should have activated	Alarm Activated (00:06)	Complied
01:20*	Ignition complete	Complied(01:20)	(In I ST attempt)
01:50*	Start of Diesel Spray	Diesel Spray Started (01:50)	
02:00*	Manual activation of suppression system	Activated Suppression System (02:00)	
02:30*	FDSS should have suppressed the fire	Fire Extinguished (02:07)

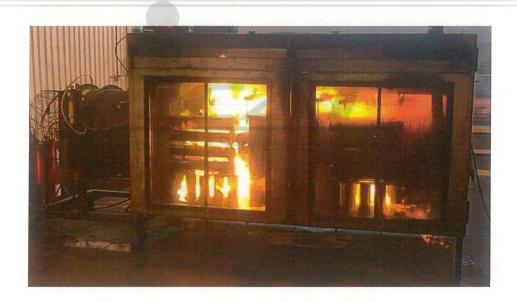
High Fire Load with Fan Scenario

Table (C) High Fire Load Scenario with Fan (as per Appendix 4):

TIME REQUIRED (mm:ss)	ACTION	OBSERVATION / ACTUAL TIME RECORDED (mm:ss)	TEST RESULT
00:00*	Start Igniting	Ignited Fire	Complied (In I ST attempt)
00:10*	Alarm should have activated	Alarm Activated (00:07)	
01:00*	Ignition complete	Complied(01:00)	
01:30*	Start the Fan (Air Flow – 1.5 m³/sec)	Fan Started (01:30)	
01:45*	Start of diesel spray	Diesel Spray Started (01:45)	
02:00*	Manual activation of suppression system	Suppression System Activated (02:00) EXCELLENCE	
02:30*	FDSS should have suppressed the fire	Fire Extinguished (02:09)

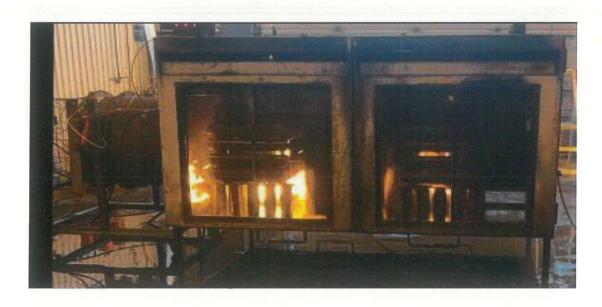
Low Fire Load Scenario

Table (B) Low Fire Load Scenario (as per Appendix 3):

TIME REQUIRED (mm:ss)	ACTION	OBSERVATION / ACTUAL TIME RECORDED (mm:ss)	TEST RESULT
00:00*	Start Igniting	Ignited Fire	Complied
00:10*	Alarm & fire suppression should have activated automatically	Alarm activated in 00:07 and suppression system activated automatically	(In I ST

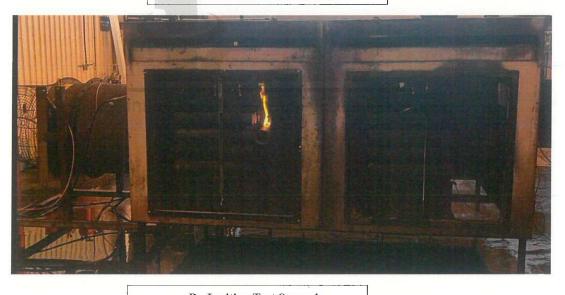
Re-Ignition Test Scenario

Re - Ignition Scenario (as per Appendix 5):

TIME REQUIRED (mm:ss)	ACTION	OBSERVATION / ACTUAL TIME RECORDED (mm:ss)	TEST RESULT
Prior to test	Pre - Heat Tube (as per clause no. 3.4.6 of Appendix 1.)	Complied	Complied (In I ST attempt)
00:00*	Predefined temperatures are reached	Test Started once the Pre- defined temperatures are reached	
00:30*	Start oil dripping	Oil Dripping started (00:30)	
00:45*	FDSS should have activated suppression system & suppressed the fire	FDSS was activated and Fire Extinguished. No Re-Ignition Occurred 45 seconds after the Extinguishing of Fire. (00:45)
